Property Inspection Services

Prepared For: Mr./Mrs. Homebuyer  
Inspector: Kevin Bush

Report #: HDsample  
Schedule Date: 5/31/2009

987 National Ave  
New Berlin, WI 53151

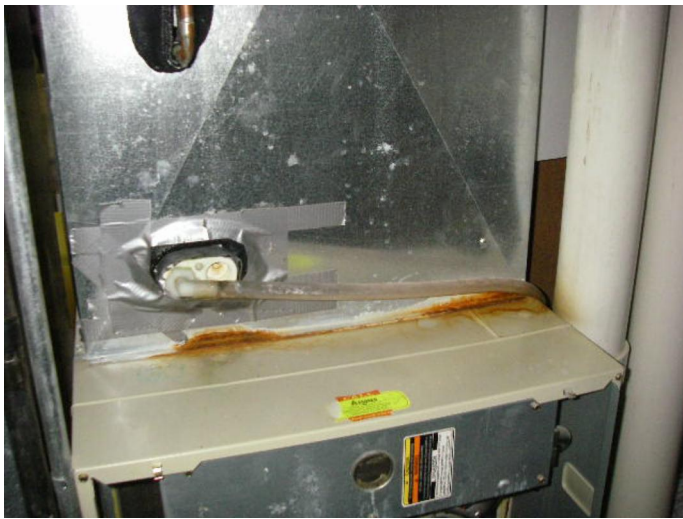
**Design**

There is heavy corrosion present and the condensate line is leaking.

The condensate line is leaking. Recommend evaluation and repair by a qualified HVAC specialist.

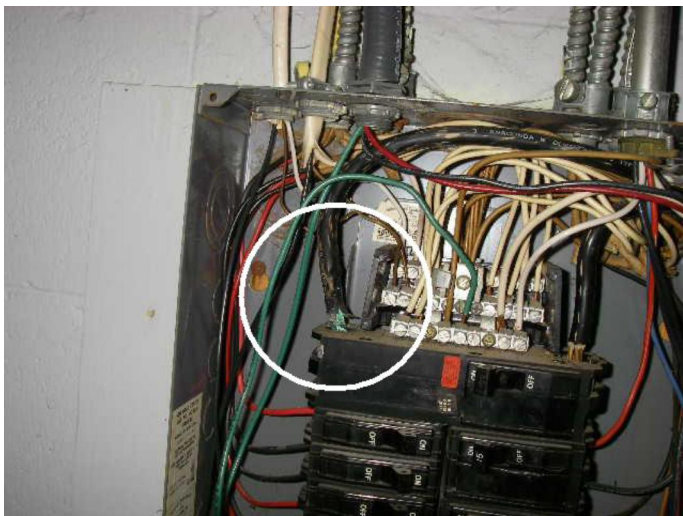
**Main Panel Condition**

Comments: The main wire is melted with signs of overheating. For safety the panel should be evaluated and repaired by a qualified electrician.

The main wire is melted with signs of overheating.

The main wire is melted with signs of overheating. For safety the panel should be evaluated and repaired by a qualified electrician.
